Fire Resistance Test Generally  
In Accordance With BS EN  
1634-1: 2014 On Specimens Of  
Floor Mounted Access Hatches

390808

**Panel Technologies**

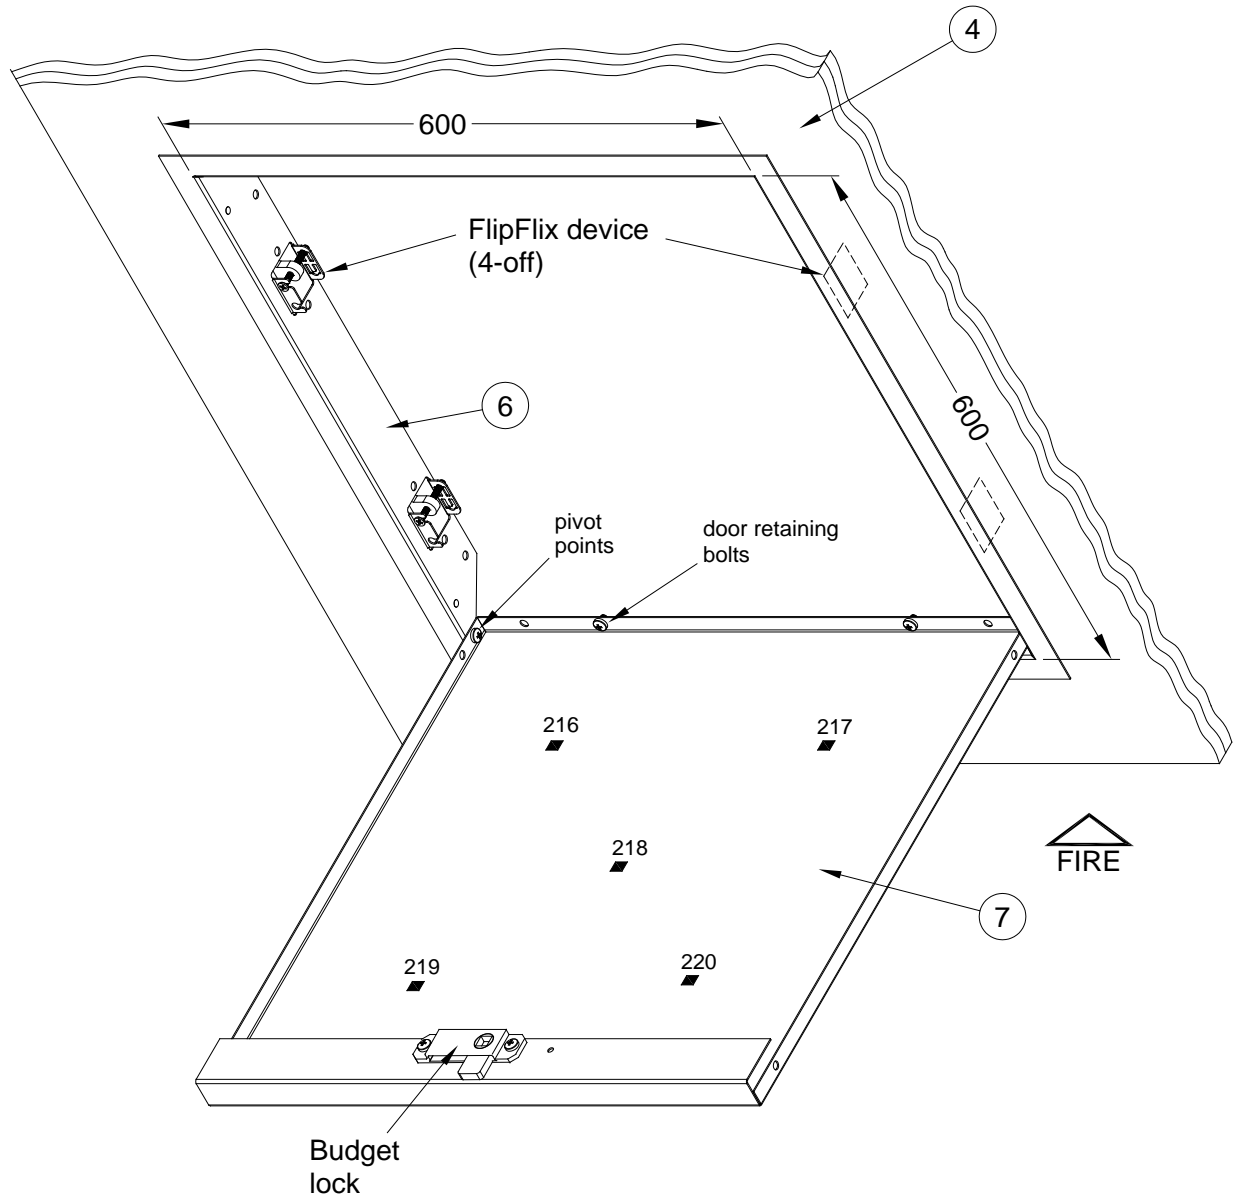
**Figure 4 – Details of Access Panel 'A'**

- Positions of surface mounted thermocouples on unexposed face of access door panel (nos.216 to 220)

**ISOMETRIC VIEW OF ACCESS PANEL 'A' WITHIN CEILING ASSEMBLY  
(access panel shown open for clarity)**

Time Mins	T/C Number 216 Deg. C	T/C Number 217 Deg. C	T/C Number 218 Deg. C	T/C Number 219 Deg. C	T/C Number 220 Deg. C	Mean Temp Deg. C
0	34	35	35	36	37	35
2	350	370	372	382	388	372
4	469	483	499	505	509	493
6	463	468	484	490	481	477
8	488	495	506	523	502	503
10	528	540	545	555	539	541
12	539	549	554	564	545	550
14	548	557	562	573	555	559
16	566	576	582	600	580	581
18	574	579	585	610	581	586
20	591	594	602	628	597	602
22	606	604	615	641	607	615
24	620	620	629	654	619	628
26	630	629	639	664	628	638
28	642	642	648	672	636	648
30	652	652	658	680	642	657
32	660	657	665	689	650	664
34	669	664	674	697	649	671
36	686	682	691	712	660	686
38	696	690	700	712	665	693
40	702	700	707	716	673	700
42	713	711	718	723	678	709
44	716	713	724	725	680	712
46	724	725	731	730	690	720
48	732	732	744	742	707	731
50	744	743	753	752	460	690
52	750	750	761	754	441	691
54	760	757	772	764	466	704
56	766	762	781	771	457	707
58	773	767	787	776	478	716

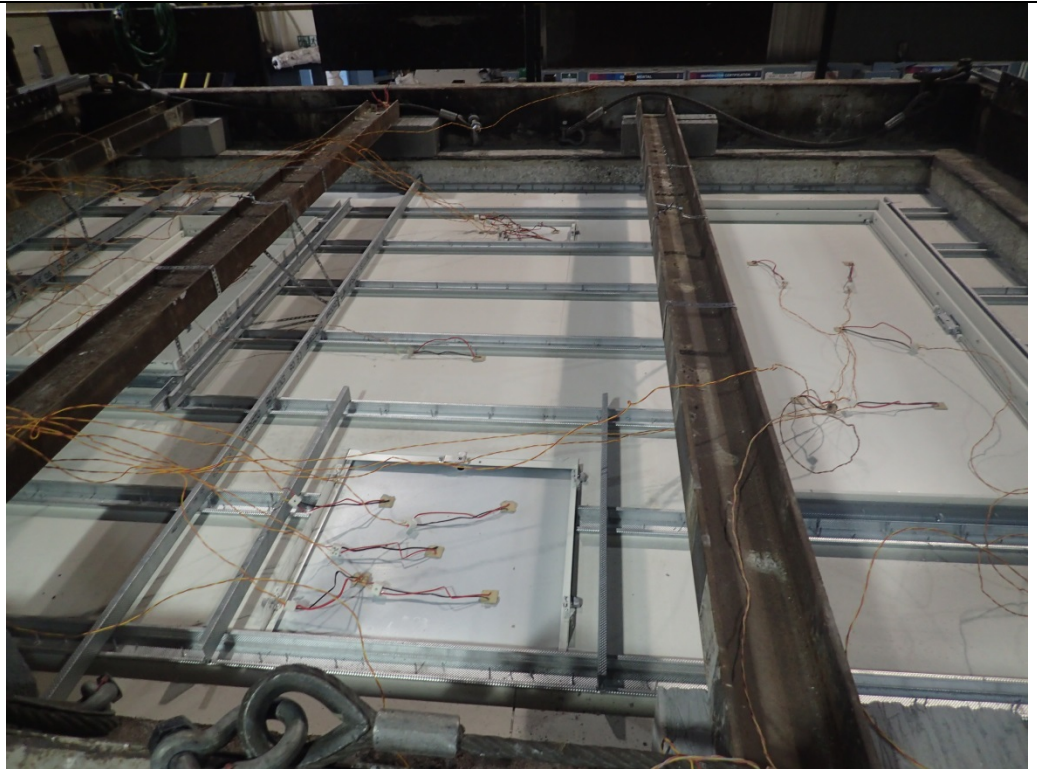
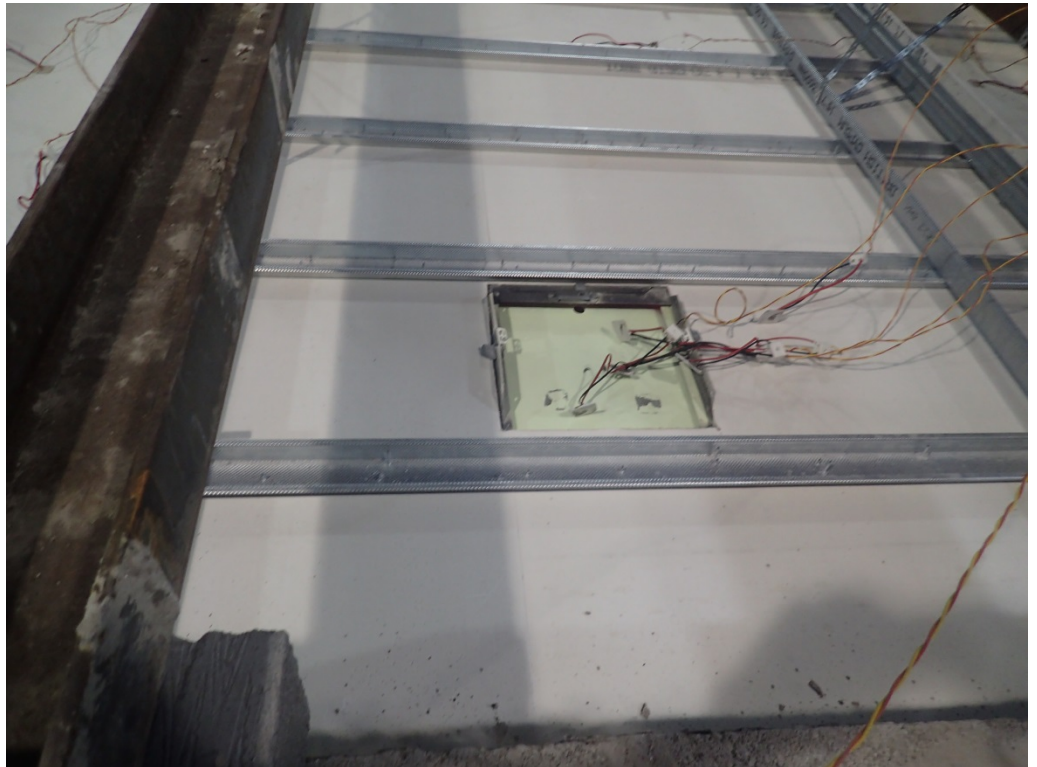
The unexposed face of the assembly during the test

Time		All observations are from the unexposed face unless noted otherwise.
mins	secs	The ambient air temperature in the vicinity of the test construction was 20°C at the start of the test with a maximum variation of 1°C during the test.
00	00	The test commences.
01	00	Specimen B begins to discolour.
02	00	Smoke release from Specimens A and B is evident.
10	00	A cotton pad integrity test is performed over the leaf of Specimen A. The pad ignites. <b>Cotton pad integrity failure is deemed to occur.</b>
13	00	A cotton pad integrity test is performed over the leaf of Specimen B. The pad ignites. <b>Cotton pad integrity failure is deemed to occur.</b>
28	30	Viewed from the exposed face: Specimens A & B are flat to the ceiling,
30	00	Specimens A & B continue to satisfy the integrity criteria.
45	00	Viewed from the exposed face: the first layer of board detaches from the ceiling creating gaps onto the second layer.

60	00	Specimens A & B satisfy the test criteria apart from cotton pad.
65	00	Specimen A fails gap gauge along the right leading edge.
66	00	<b>Test Discontinued.</b>

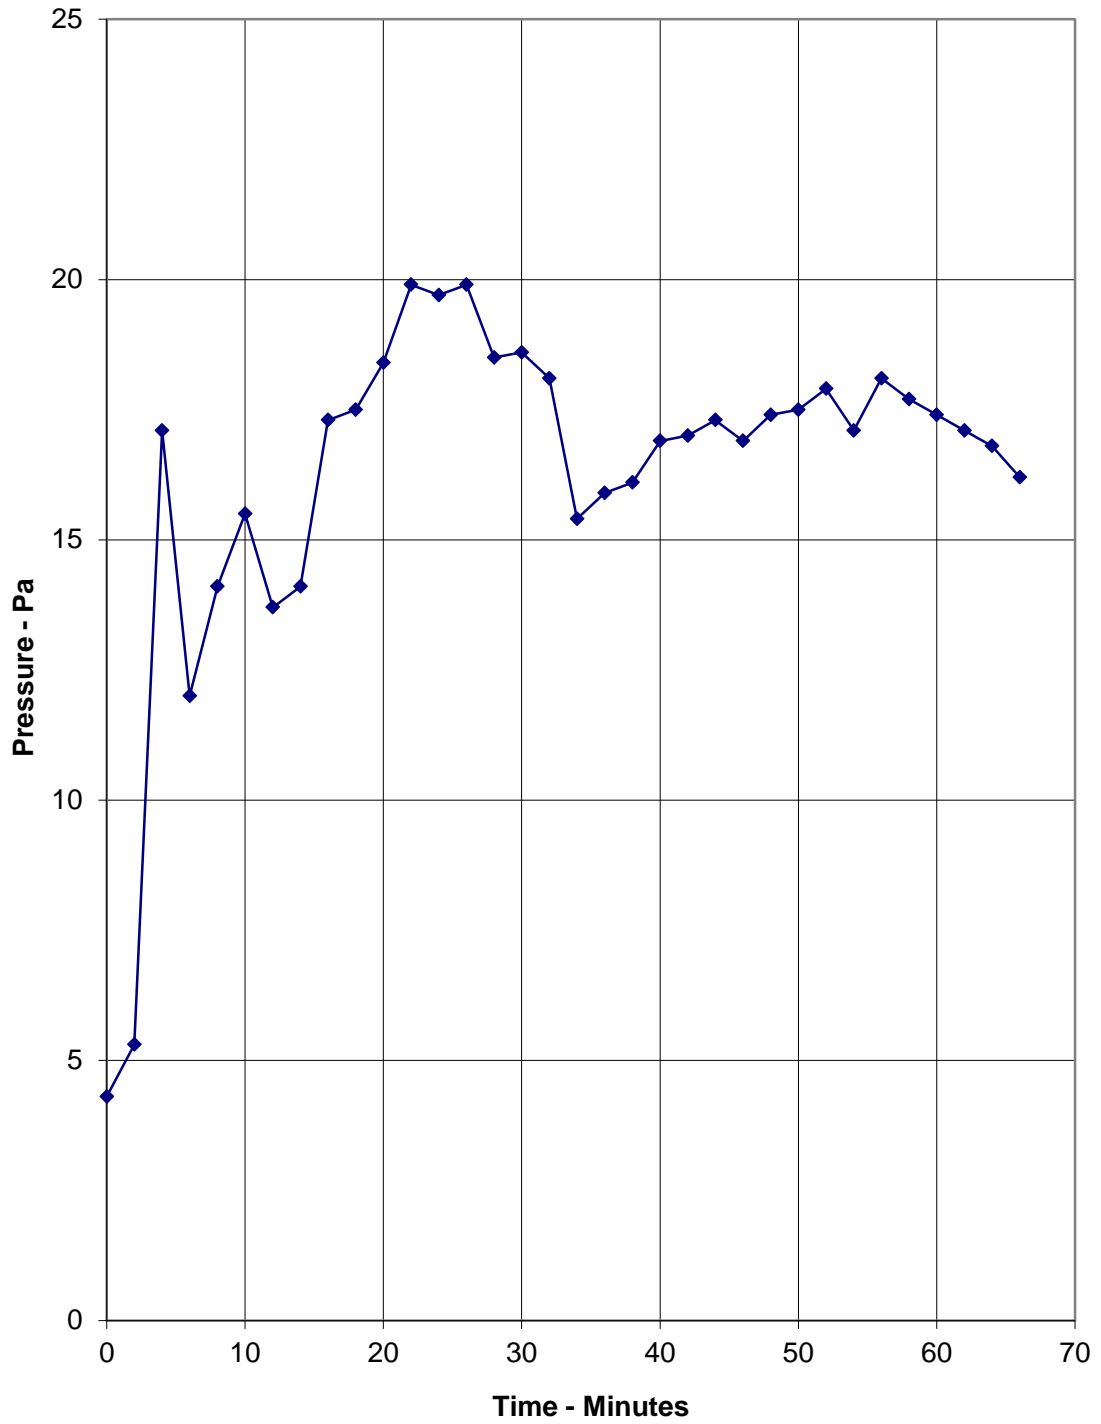
**Recorded Furnace Pressure 100 mm Below The Assembly**

<b>Integrity Criteria</b>	Cotton pads and gap gauges were available to evaluate the integrity of the specimen.
<b>Furnace Pressure</b>	After the first five minutes of testing, the furnace pressure was controlled to maintain a slightly positive pressure relative to the pressure of the laboratory. The furnace atmospheric pressure was measured and controlled such that, 100 mm below the soffit of the specimen assembly, the differential pressure was calculated to be 20 (+0 -3) Pa.

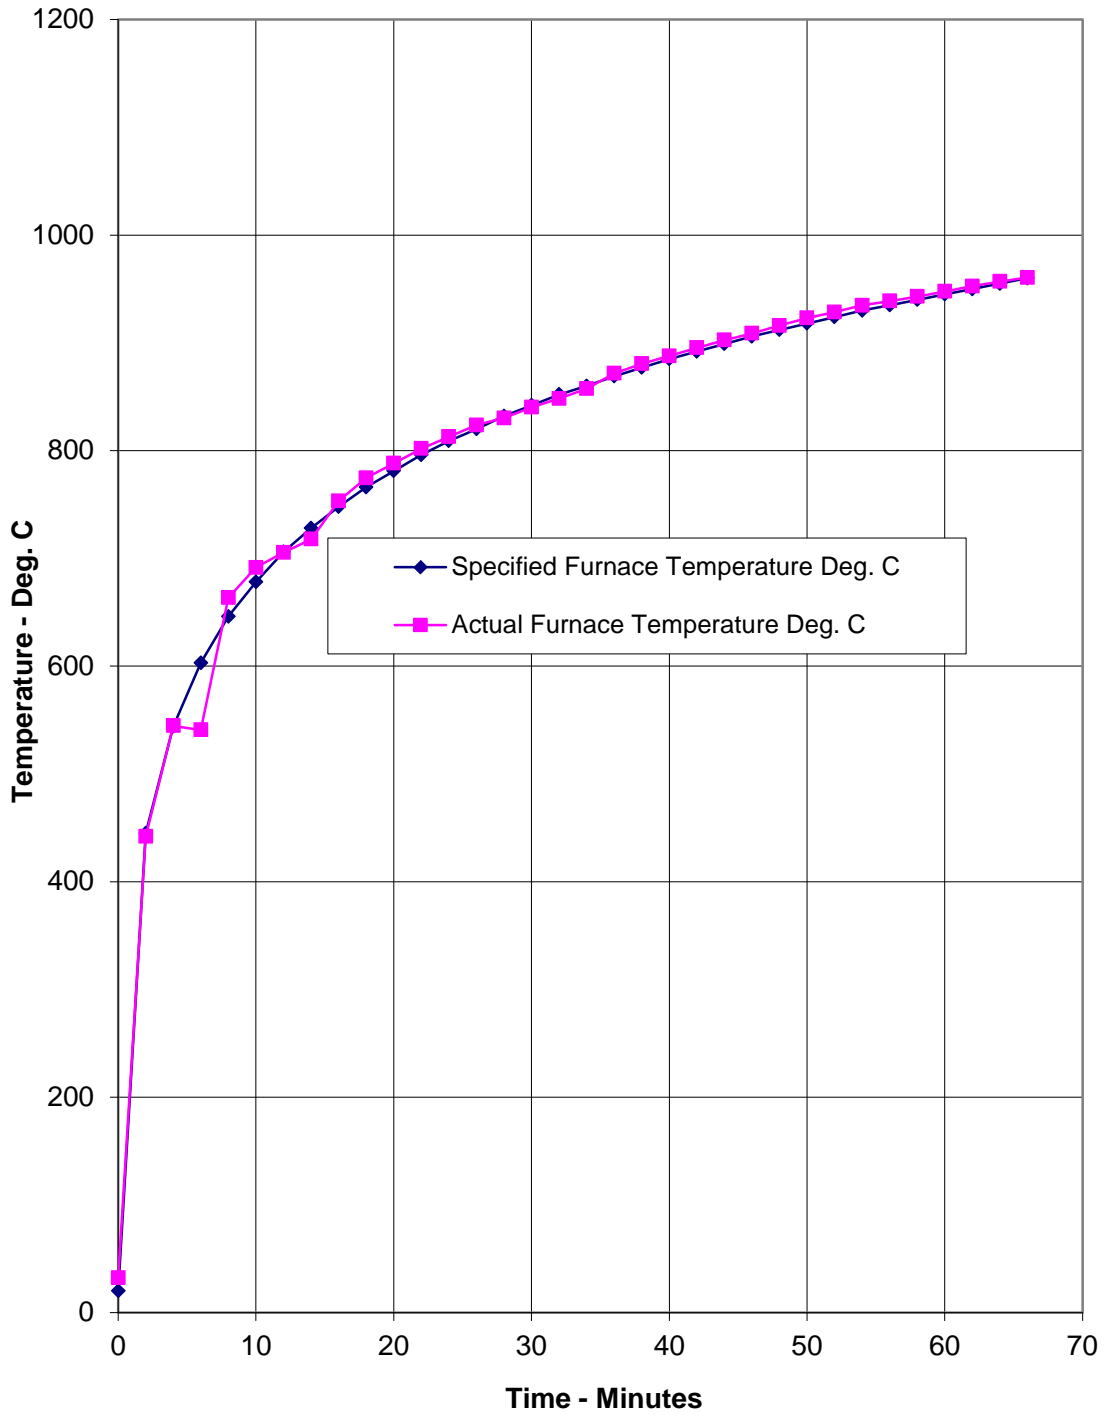
**Graph Showing Mean Furnace Temperature, Together With The Temperature/Time Relationship Specified In The Standard**

Time Mins	Specified Furnace Temperature Deg. C	Actual Furnace Temperature Deg. C
0	20	32
2	445	442
4	544	545
6	603	541
8	646	663
10	678	692
12	706	706
14	728	718
16	748	753
18	766	775
20	781	788
22	796	802
24	809	813
26	820	824
28	832	830
30	842	840
32	852	848
34	860	857
36	869	872
38	877	881
40	885	888
42	892	896
44	899	903
46	906	909
48	912	916
50	918	923
52	924	929
54	930	935
56	935	939
58	940	943
60	945	948
62	950	953
64	955	957
66	960	961
