Fire Resistance Test Report

Report: BMT/FEI/F14107 Revision A

A fire resistance test performed on a non load bearing 60 minute ceiling membrane fitted with a loft hatch
Test conducted to BS EN 1364-2: 1999 to the temperature and pressure conditions outlined in BS EN 1363-1: 2012

Test date: 11th September 2014

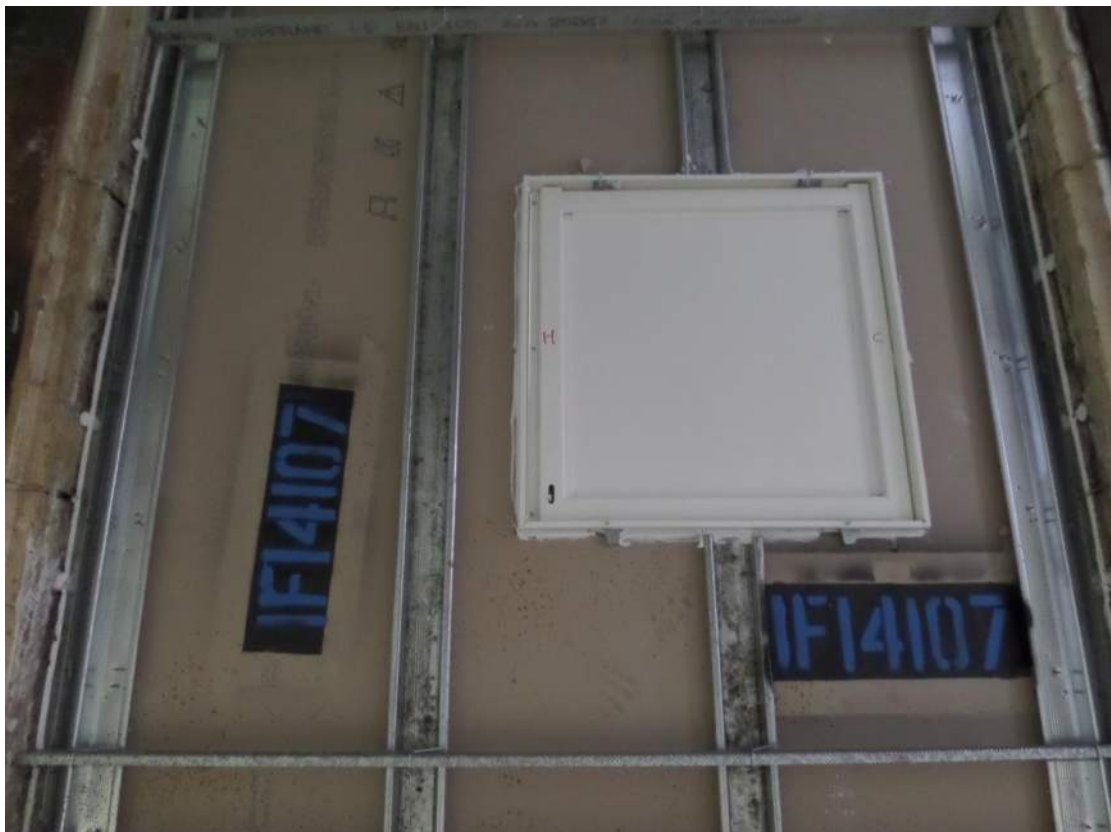
Unexposed face prior to testing

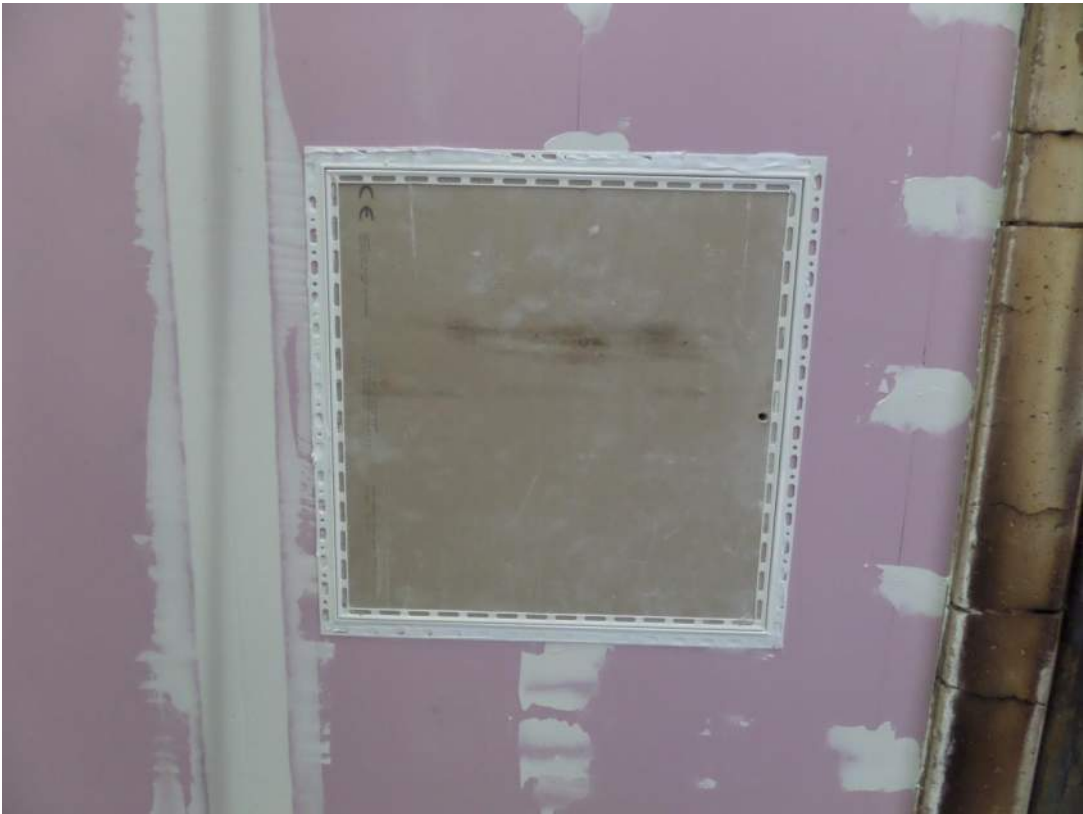
Exposed face prior to testing

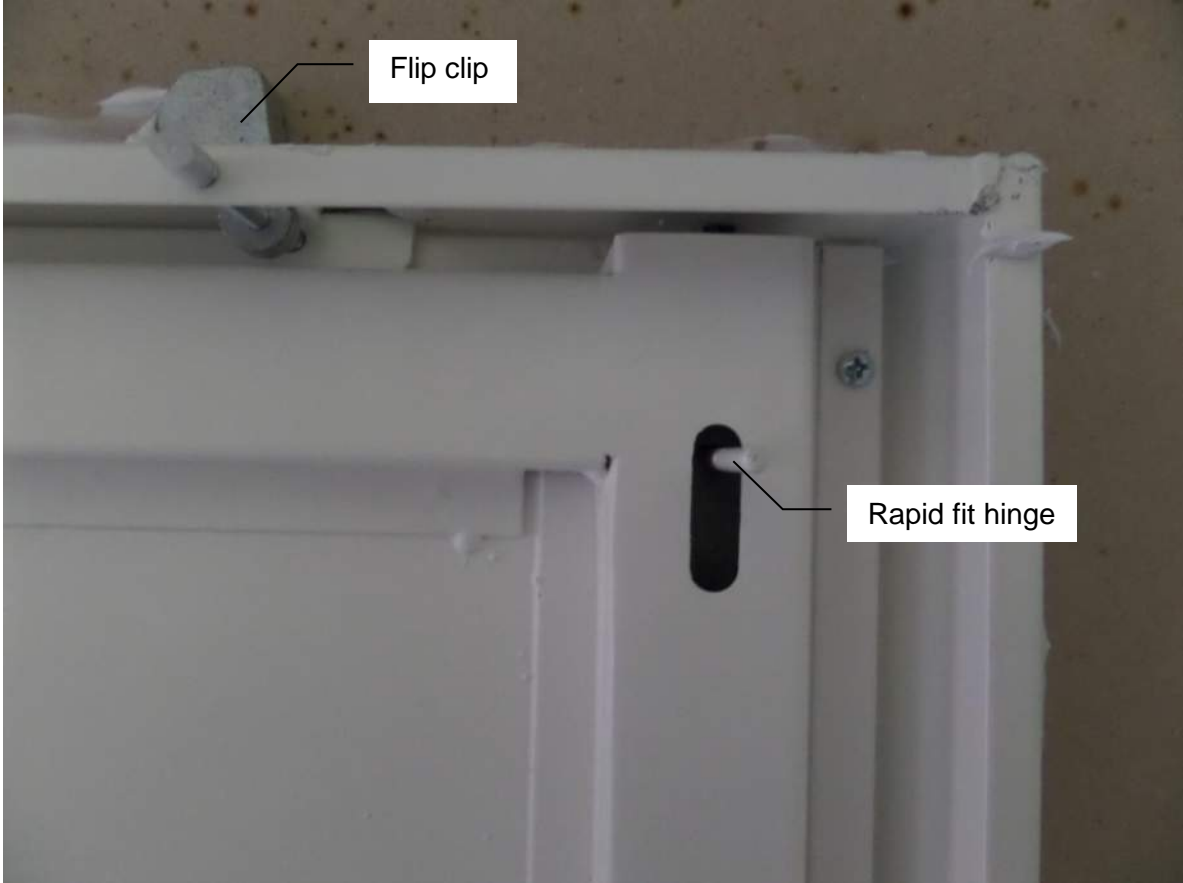
Hardware at top right hand corner of unexposed face.

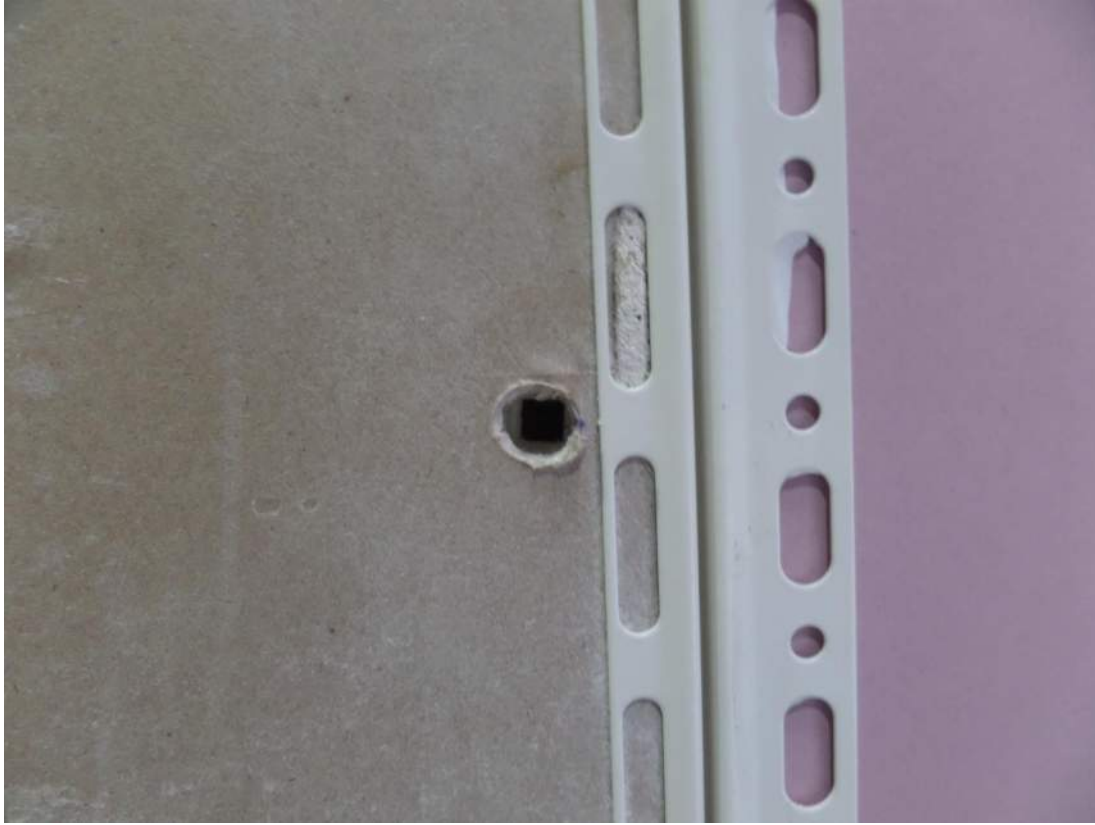
Budget lock key hole on exposed face

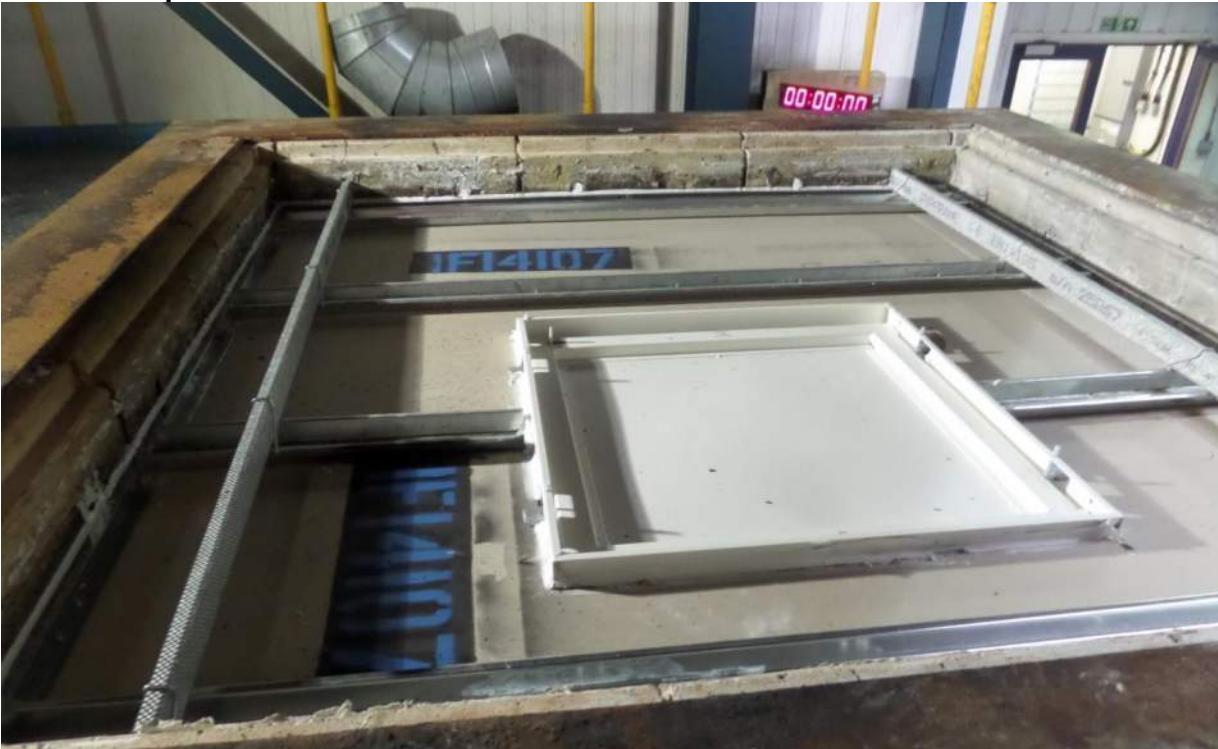
Unexposed face at start of test

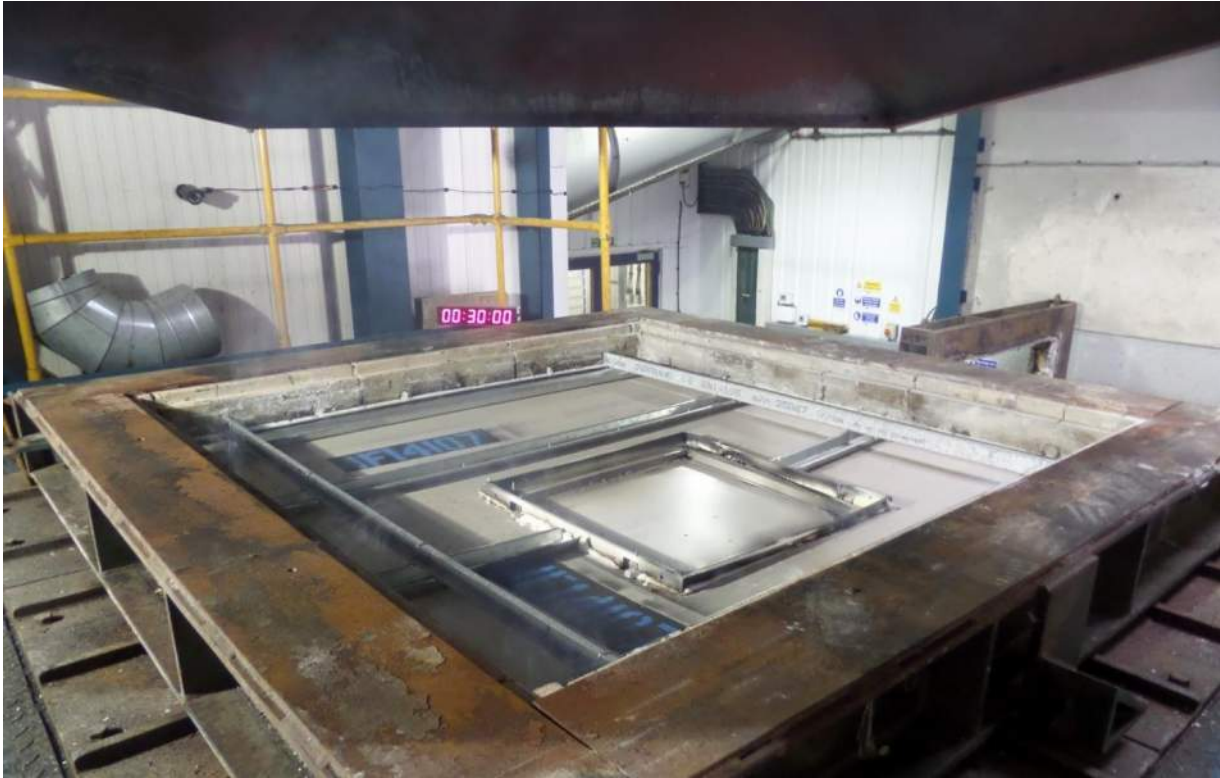
At 30 minutes

25.10	There is further discolouration to the edge of the leaf.
32.30	The top closing corner of the leaf has deflected into the furnace by approximately 7-10mm.

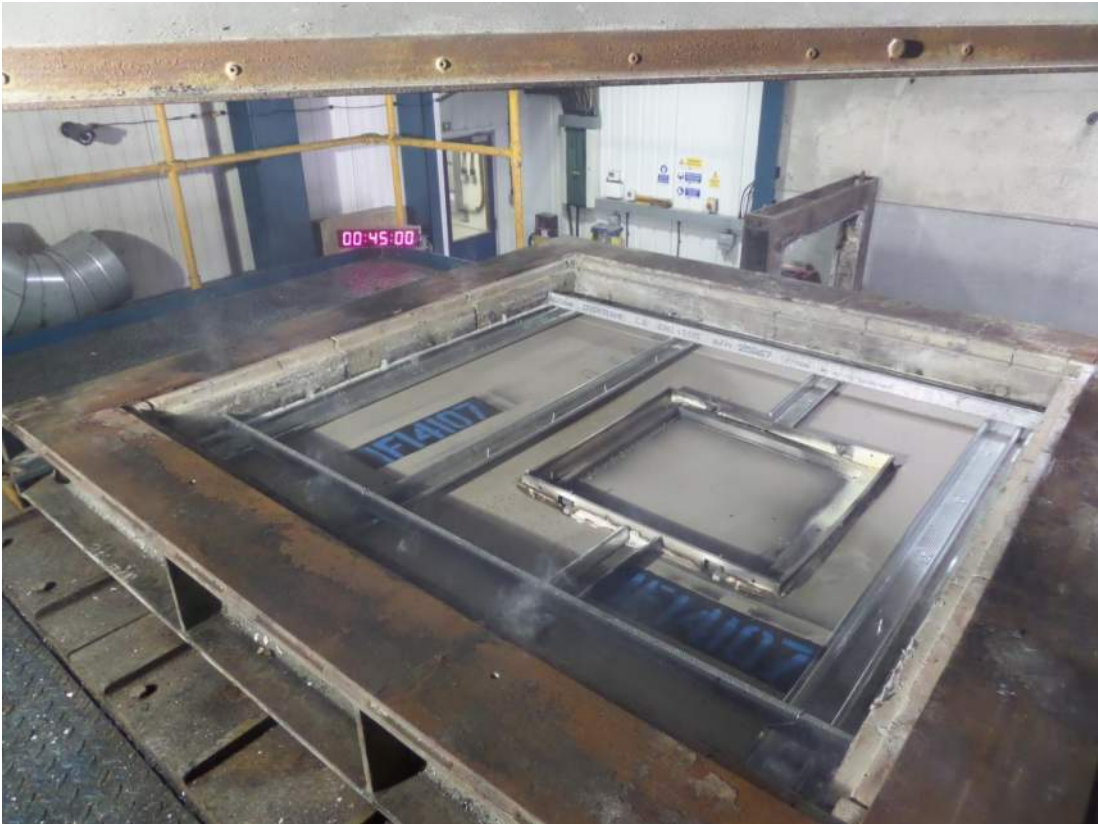
At 45 minutes

43.30	There is discoloration over the entire face of the leaf.
52.00	Exposed face, the first layer of the plasterboard is starting to fall away from the ceiling membrane.

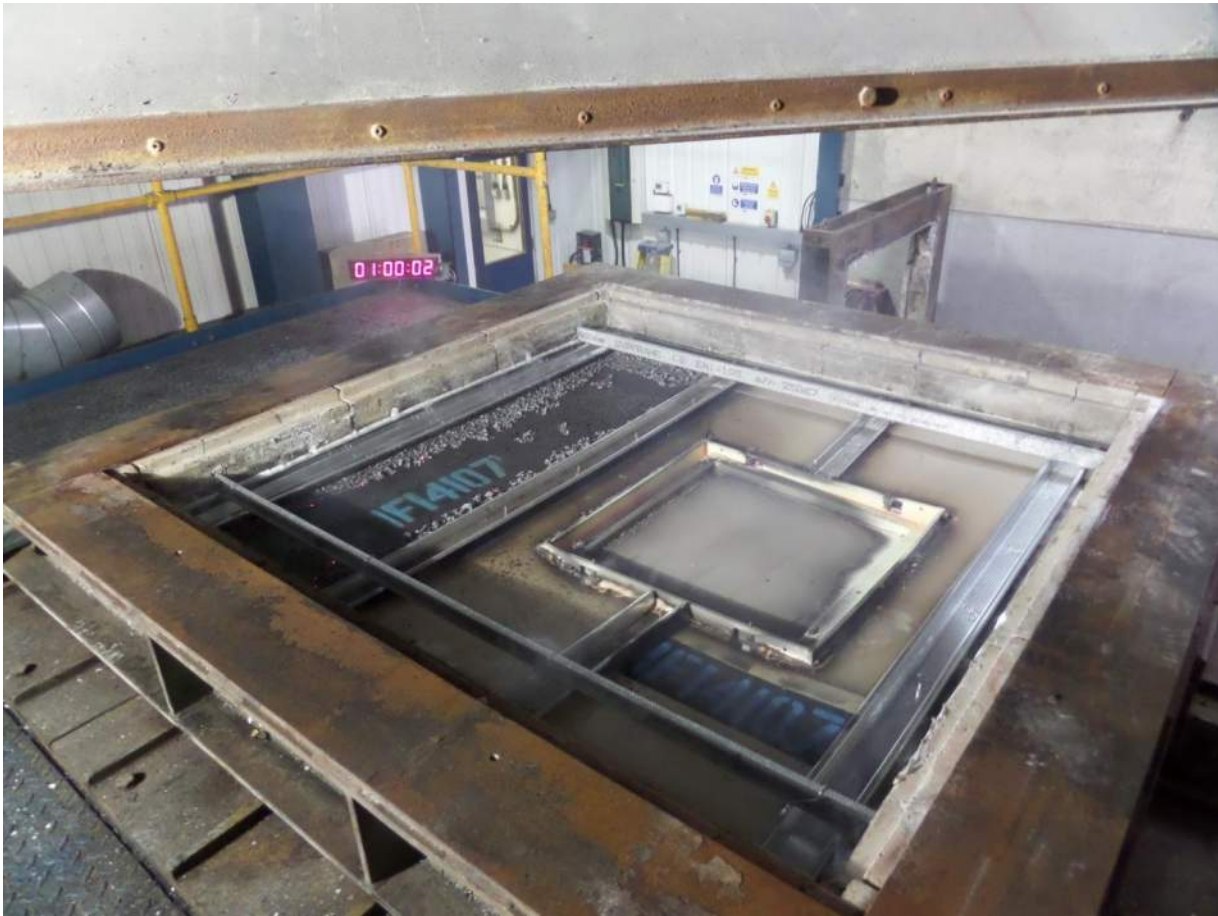
After 60 minutes

55.00	The top closing corner of the leaf has deflected into the furnace by approximately 10-15mm.
56.00	There is discolouration to the ceiling at the perimeter of the frame.

63.00	The specimen is starting to fall through the ceiling at the hanging edge.
64.00	Test terminated.
