Fire Resistance Testing

Report: BMT/FEI/F14064 Revision A

A fire resistance test performed on two loft access hatches fitted within a British Gypsum 60 minute specification ceiling membrane section

Test conducted under the temperature and pressure conditions outlined in BSEN 1363-1: 2012 and generally in accordance with BSEN 1364-2: 1999

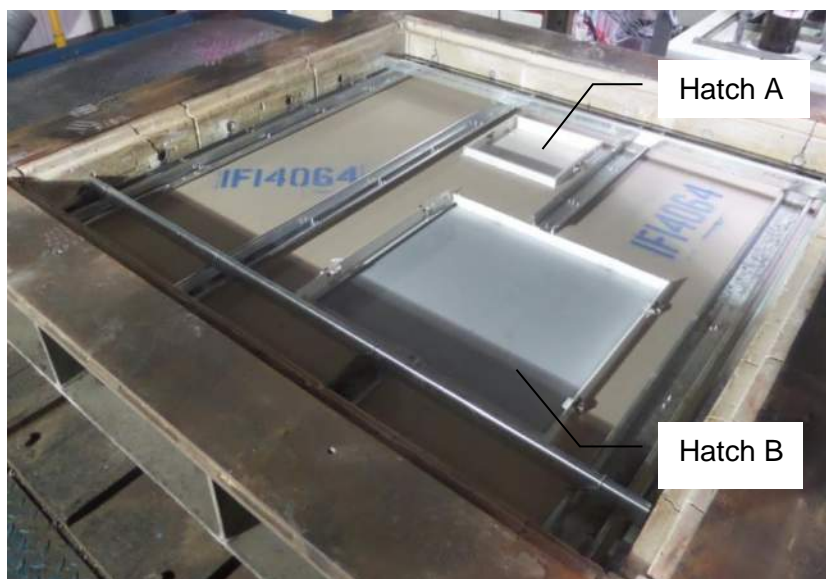
Unexposed face prior to testing

Warringtonfire constructed a section of British Gypsum (BG) CasoLine MF 60 minute ceiling membrane within a refractory lined steel restraint frame. The ceiling included a 605mm x 605mm aperture and a 305mm x 305mm aperture, into which Warringtonfire installed the loft access hatches.

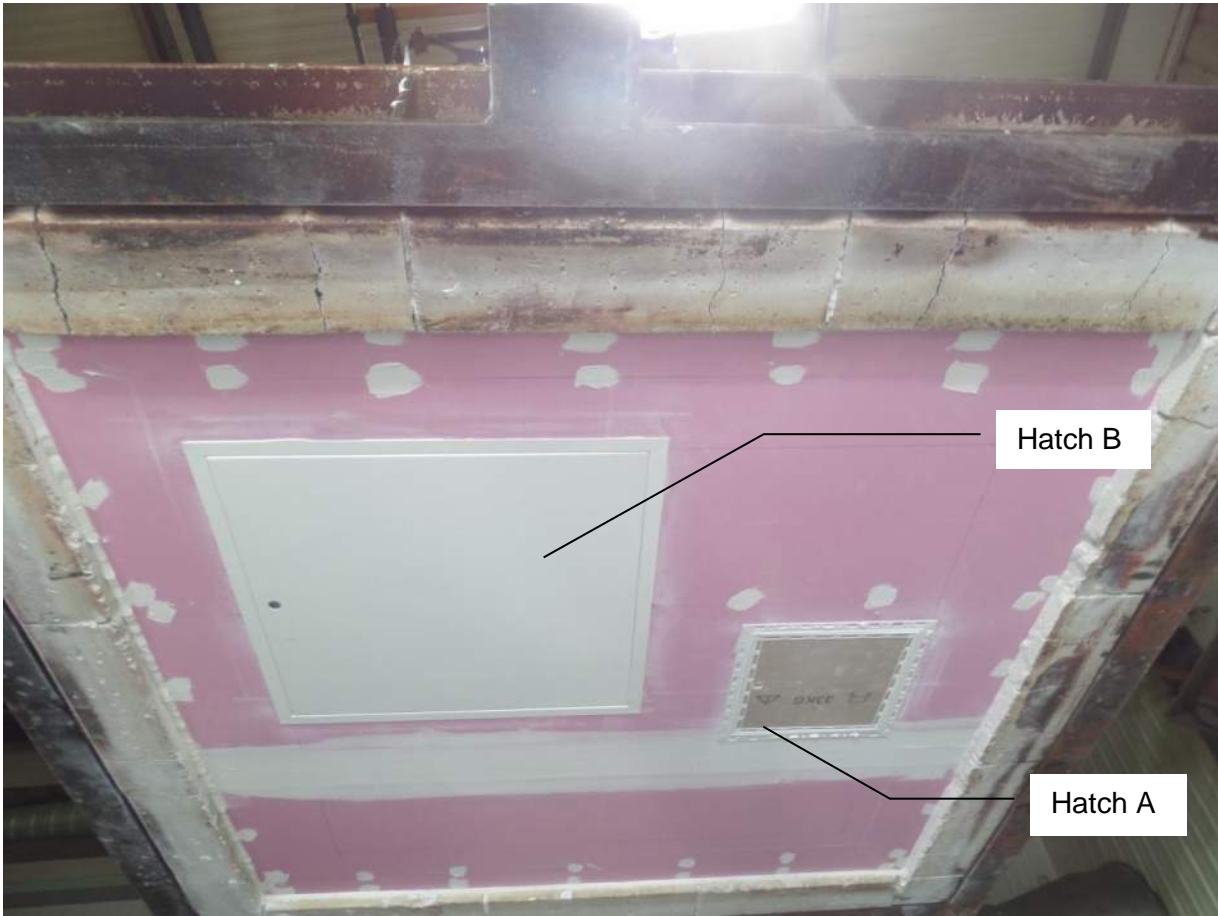
Exposed face prior to testing

Description of the ceiling membrane construction - Reference British Gypsum CasoLine MF 60 minute system ref. C106003

The 1500mm x 1500mm ceiling construction comprised BG Gypframe M6F Primary Support Channel around the ring beam and BG Gyframe MF5 Ceiling Section fitted within the MF6 Primary Support Channel profile at 450mm centres. 2No.sections of BG Gypframe MF7 Primary Support Channel were fitted 1200mm apart to one side of the each hatch aperture, at 90° to the MF5 ceiling section, extending to the MF6 Support channel around the ceiling section. The ceiling system was clad with 2No. layers of 12.5mm thick BG Gyproc FireLine board, the first layer fixed with 32mm long Drywall screws and the second layer with 42mm long Drywall screws, all fitted at 230mm centres.

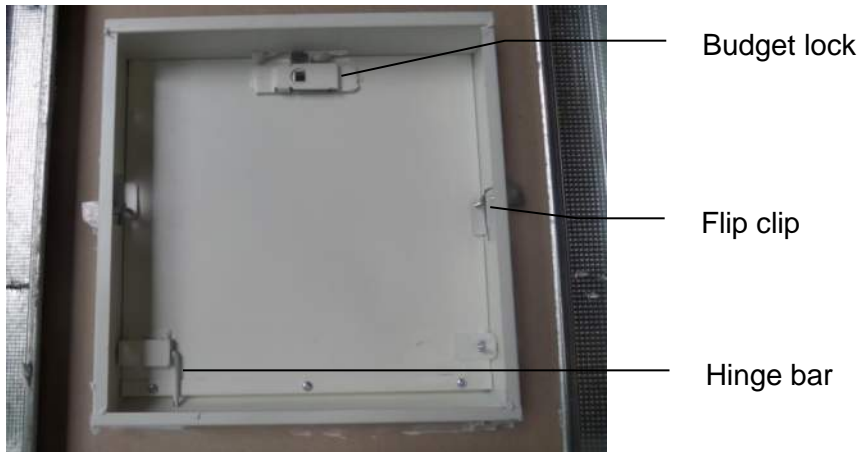
Access hatch A

The hatch panel (Plasterboard Faced Flipfix) measured 290mm long x 290mm wide x 60mm thick. The hatch panel frame comprised powder coated 1mm thick perforated profiled steel enclosing a 12.5mm Siniat/GTEC Megadeco core. The frame comprised 1mm thick powder coated perforated steel 300mm high x 300mm wide including a 25mm wide architrave. The frame was fixed into the aperture with 2 No. 'flip clip' adjustable fixings centrally fitted on opposite edges.

The loft access hatch was hinged on a Ø4mm steel bar at one edge, with an engaged budget type latch (79mm x 22mm) centrally fitted on the opposite edge.

The hatch panel comprised a tray profile 15.5mm thick, welded at the corners.

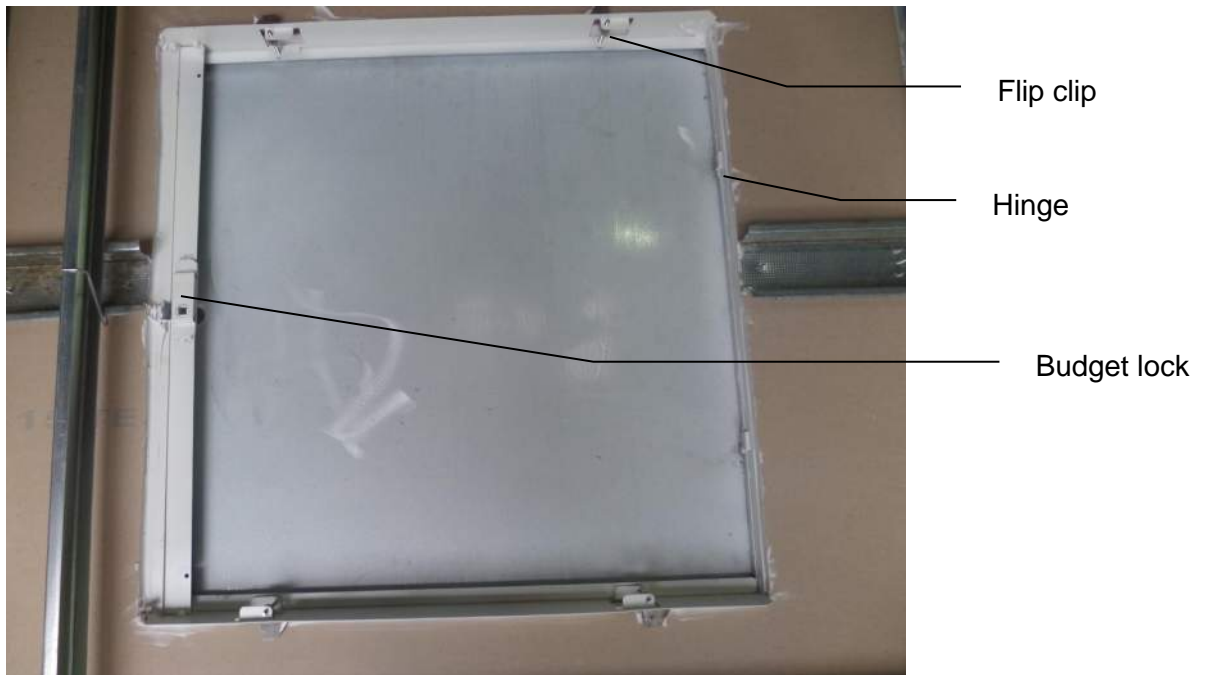
Access hatch B

The hatch panel (Metal Faced Flipfix) measured 598mm long x 598mm wide x 55mm thick. The hatch panel comprised powder coated 0.9mm thick profiled steel. The frame comprised 0.9mm thick powder coated steel 600mm high x 600mm wide including a 25mm wide architrave. The frame was fixed into the aperture with 4 No. 'flip clip' adjustable fixings. 2 No fixings were present on 2 edges, 120mm from corners on adjacent sides.

The loft access hatch was hinged on two Ø5mm steel bolts on one edge, with an engaged budget type latch (79mm x 22mm) centrally fitted on the opposite edge.

The hatch panel comprised a tray profile 13mm thick, welded at the corners.

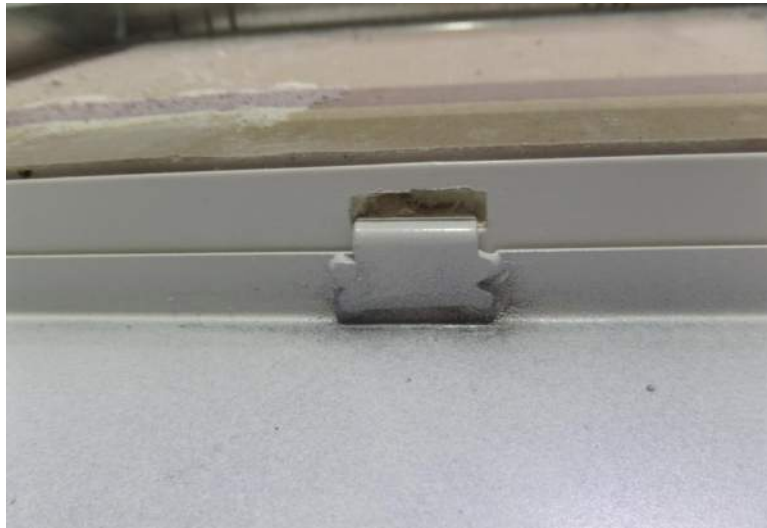
Hinge mechanism as fitted to Hatch B

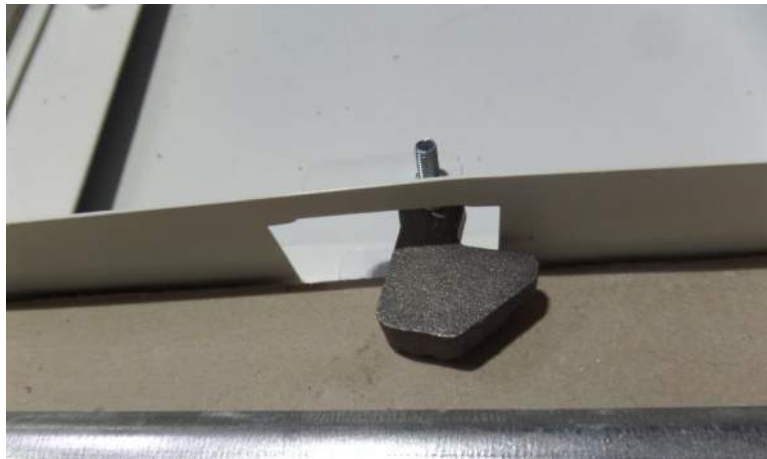
Flip clip as fitted to both hatches

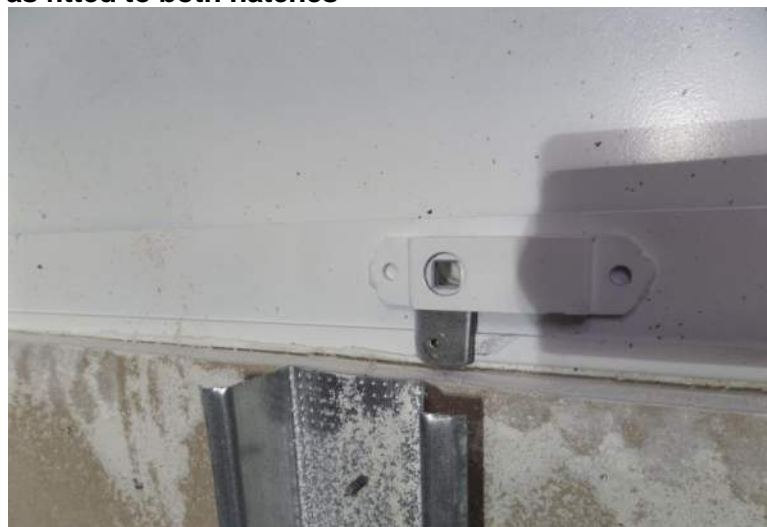
Budget lock as fitted to both hatches

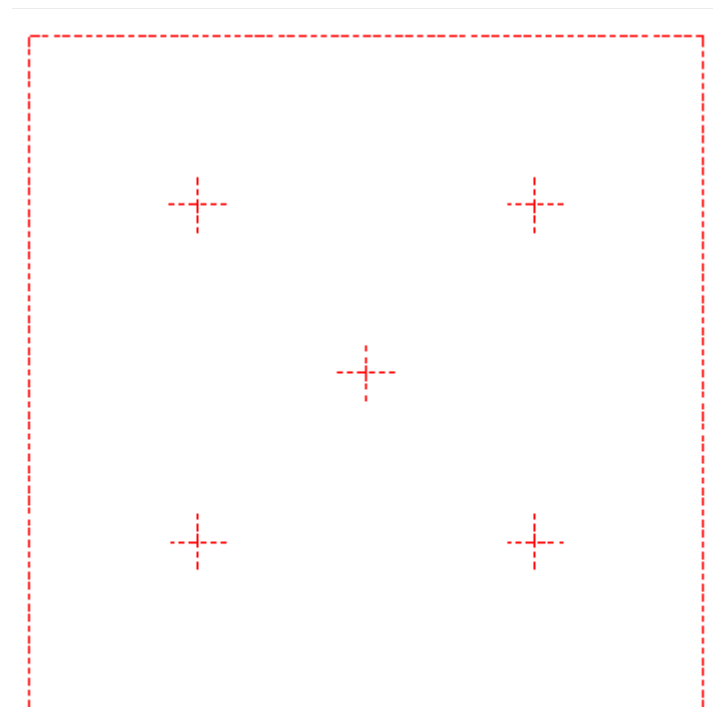
The furnace was controlled to follow the temperature/time relationship specified in BSEN 1363: Part 1: 2012 Section 5.1.1 as closely as possible, using the average of five plate thermometers suitably distributed within the furnace. The temperatures recorded have been tabulated in Appendix 2 and are shown graphically below:

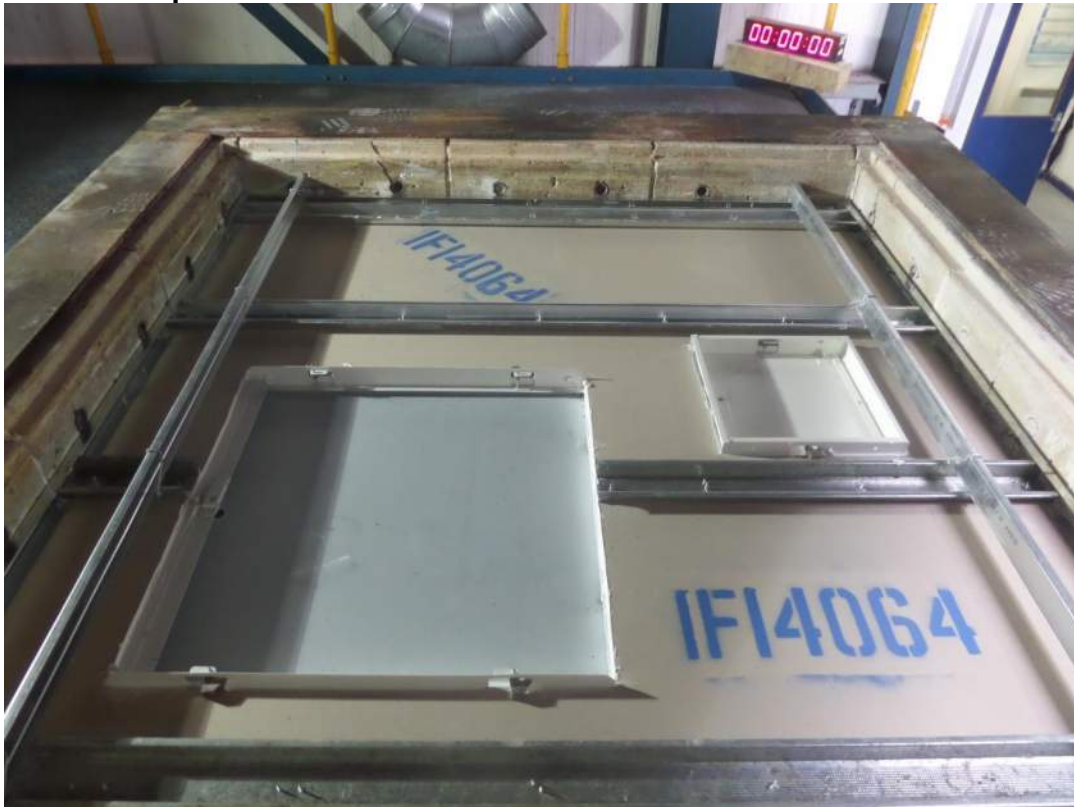
Unexposed face at start of test

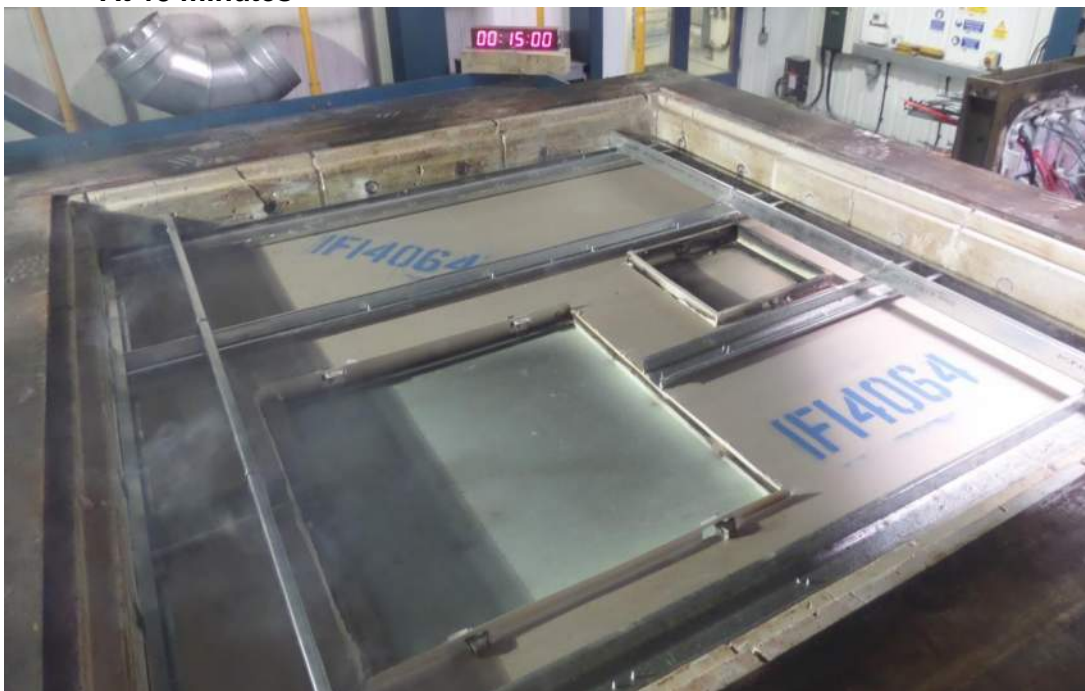
At 15 minutes

14.20	Panel A, there is further discolouration to the frame of the panel.
17.40	Panel A, the closing edge of the panel is glowing.
25.00	Panel B, the closing edge of the panel is starting to glow

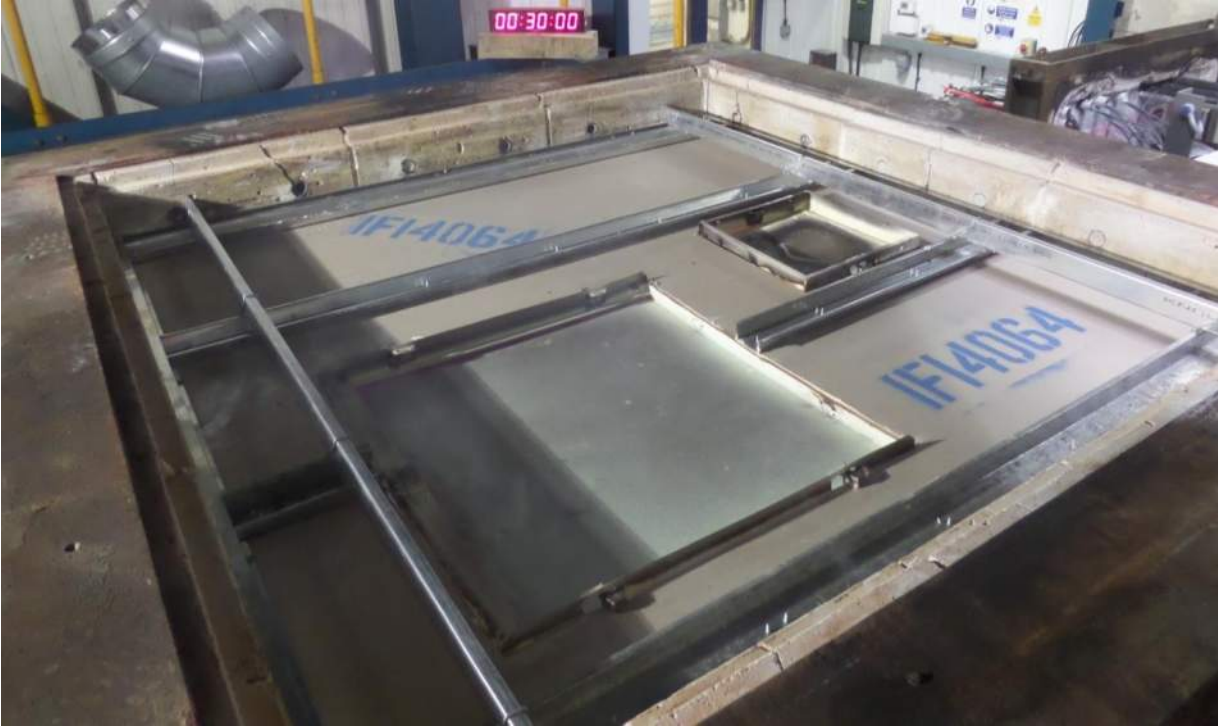
At 30 minutes

27.00	Panel B, there is further discolouration on the frame of the panel.
30.30	Panel B, there is an increase in smoke issuing from the perimeter of the panel.

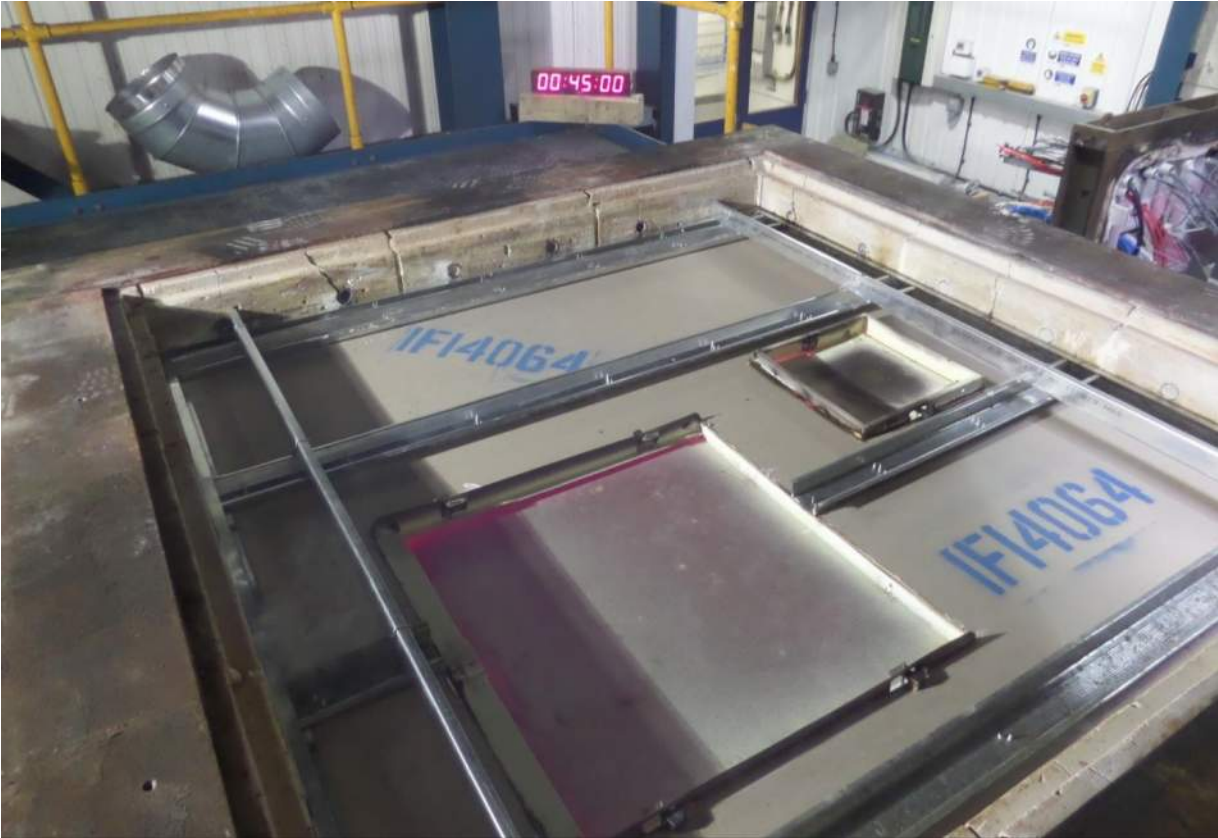
At 45 minutes

37.00	Panel A, the hinged edge of the panel is starting to glow.
42.45	Panel B, the face of the panel is glowing.
45.45	Panel A, the paint on the panel has burned away.

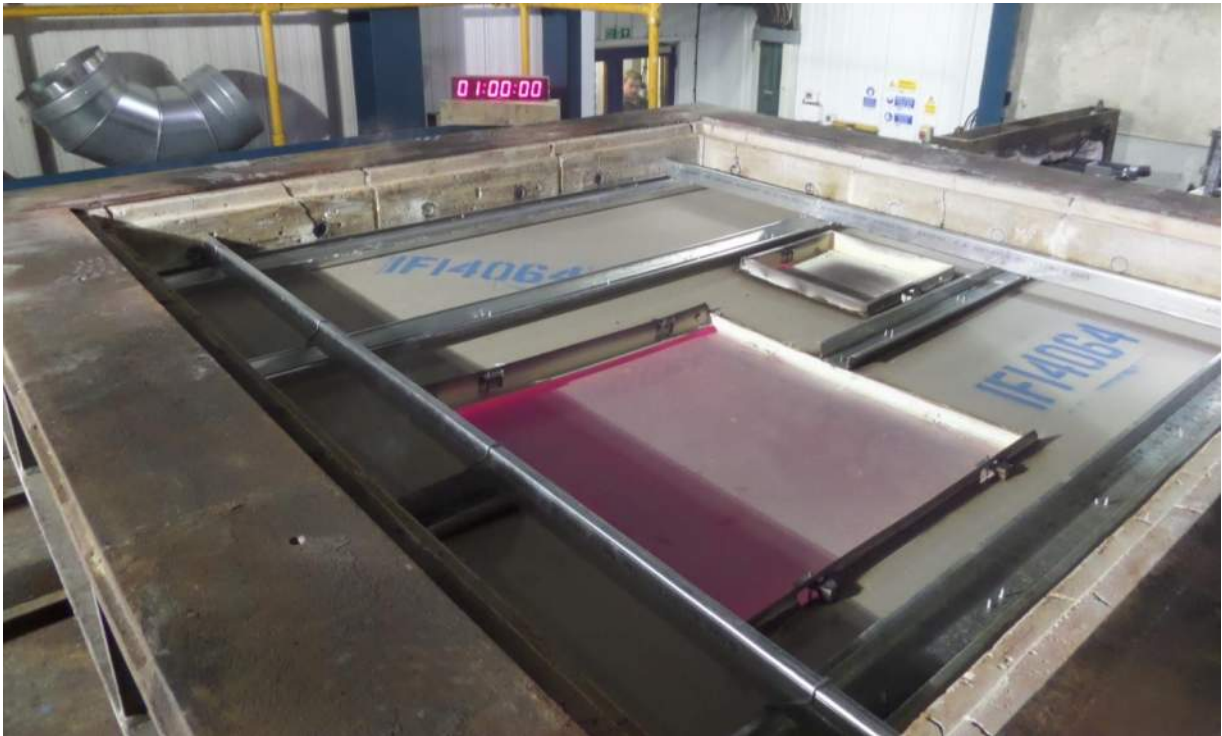
At 60 minutes

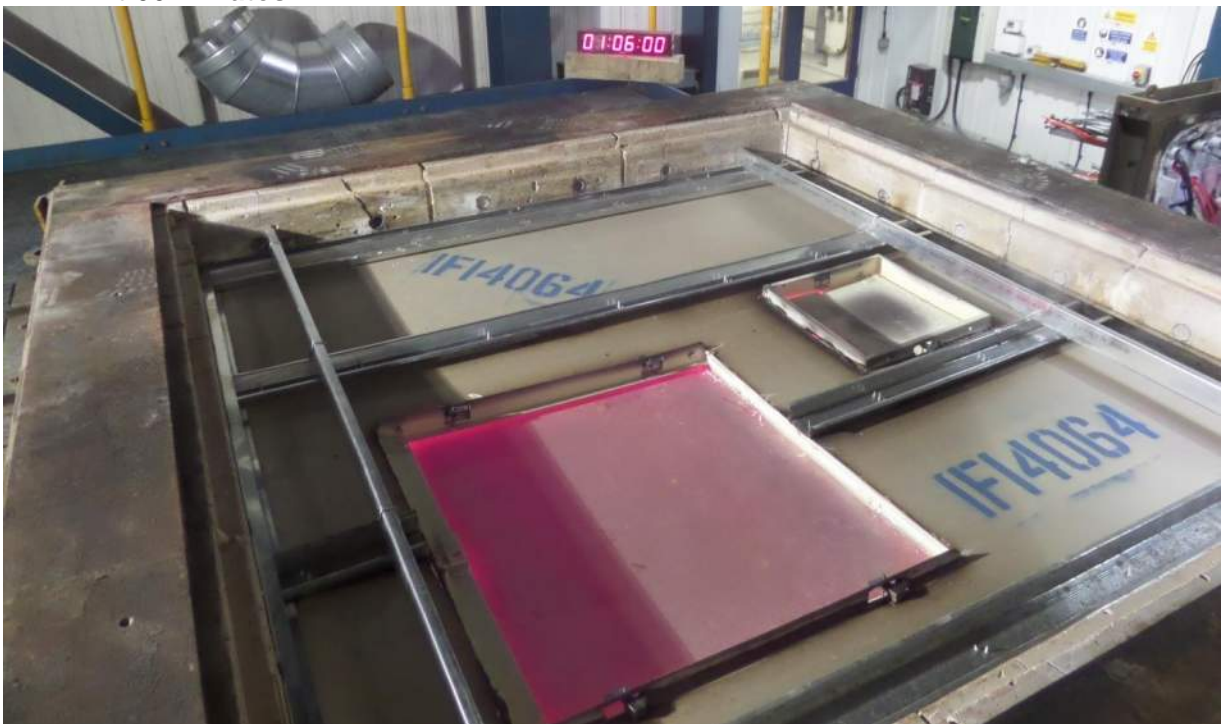
At 66 minutes

- 49.00 Panel A, there is discolouration of the plasterboard at the closing edge of the panel.
- 52.00 Panel A, there is discolouration of the plasterboard around the perimeter of the panel.
- 56.30 Panel A, the closing edge has deflected further by approximately 8-10mm.
- 66.00 Test terminated.
